Cars Worth Keeping

MGYB

When it was finally back on the road, Philip Reckless had spent £1683.45 on restoring his 1952 MG saloon

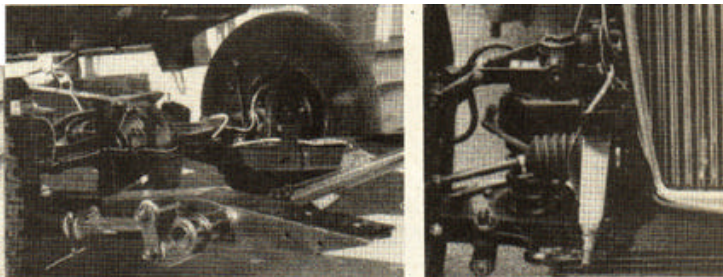
I started with the front suspension, by first disconnecting the front brake pipes from the wheel hubs. Next, I removed the bolts to the swivel pins, shock absorber and wishbone plate. On dismantling the wishbone, I found to my horror that, on the nearside, the coil spring had fractured at the base. This was not visible when the car was being used. On closer examination I realised that the spring had been in this state for some time, as the break was old and dirty.

Front suspension renovations included replacing the front coil springs, one of which was found to be broken, although the car had been running on it before the rebuild. The engine was repainted MG red.

Fortunately, I was able to purchase two new springs from my supplier, who responded to my pleas for help in double quick time. Full marks to Motobuild of Hounslow. It is advisable to fit the coil springs in pairs as, after such a long time, the originals will have reduced in strength. On mine, the reduction was nearly ¾ in.

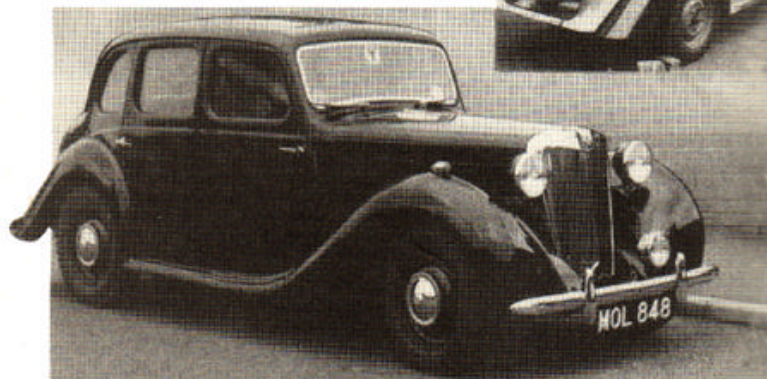
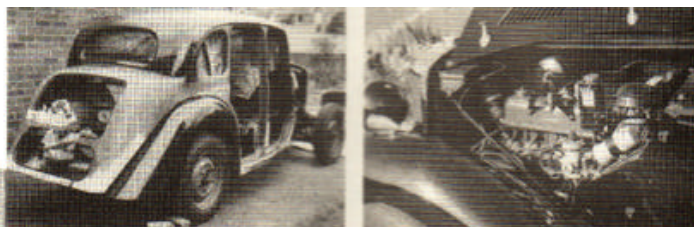
Philip Reckless gave his MG YB an even more thorough paint covering than the factory, with 30 coats (half of them undercoats) for the body. Each coat was rubbed down before the next was applied.
