The Continuing Story of TBM 895

TBM 895 is a ZB Varitone Magnette and first appeared in the June 1985 issue of *Enjoying MG*. Since the end of 1983, when the first part of the story ended, many things have happened. This has turned out to be a very long restoration project but I am sure that it will not approach the all-time record. Those of you who meet rather more demanding schedules will not be impressed... the rest of you probably won't be impressed either.

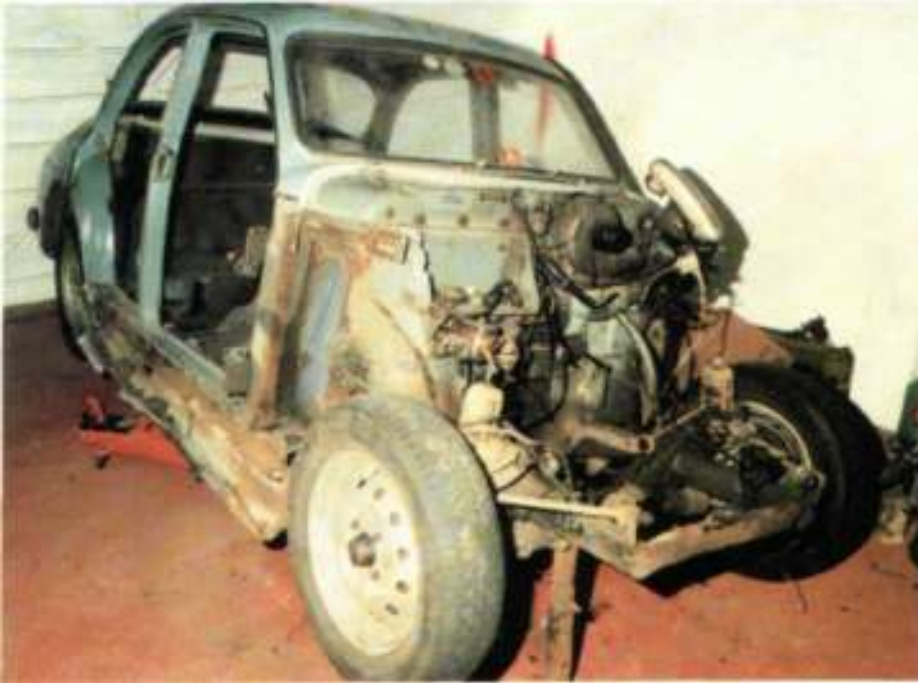
Removal of anything removable progresses in friend Dave's garage.

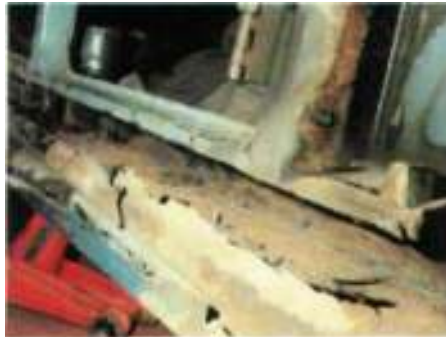
General view of rust in offside side-beam.

I was now left with a bare body-shell, still on wheels for convenience. I knew that the sill-replacements commissioned by the previous owner had been bodged and concealed extensive corrosion in the side-beams so the first major step in the restoration of the body-shell was to replace these parts (both sides) so that only sound metal remained. I also had a hope that correct replacement followed by thorough anti-corrosion protection would mean that a similar exercise might not be necessary until I was too old to care about cars. This event is a long way off despite the comments of so-called friends and family pursuing cheap laughs.

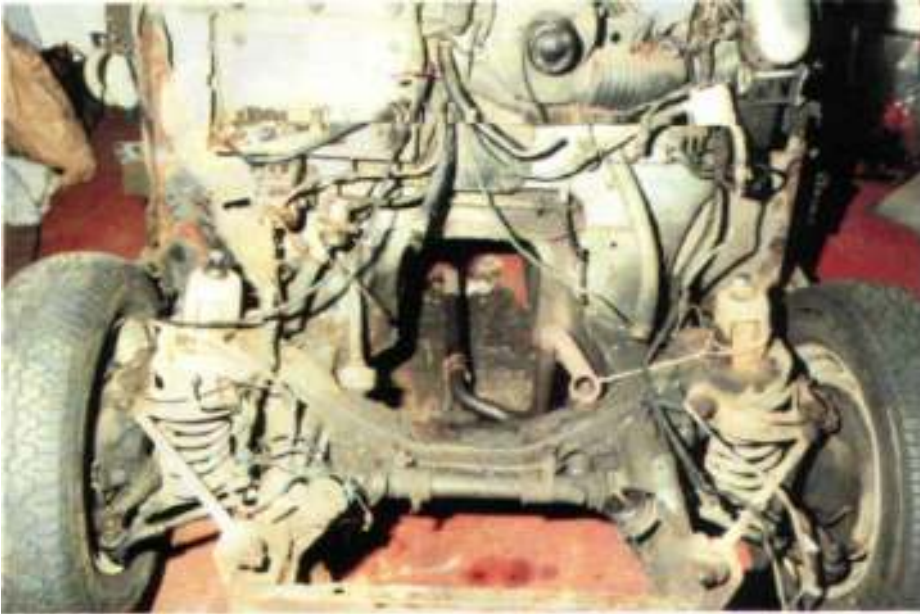
General view of front end showing its general state

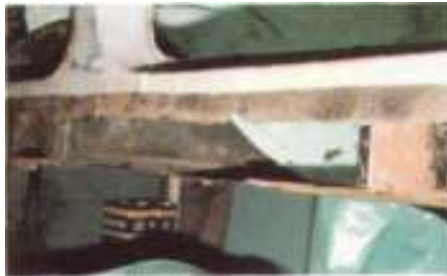
All the unground metal removed.

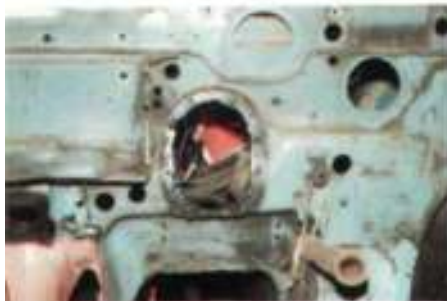
Bulkhead after initial cleaning.

The early part of 1985 was spent removing all the suspension from the car. I then stripped the front chassis-legs of all paint and rust, gave the bulkhead the same treatment and then repainted with silver-grey Hammerite. This was all done in the cool winter evenings and it took rather a lot of them to get to the repainting stage. The spring turrets proved especially difficult - although they were very sound their interiors showed their years. A fair depth of rust flakes had to be removed by chipping away with small chisels, old screw-drivers and the like. At times the work seemed more akin to archaeology! The commission plates etc. removed from the bulkhead were almost illegible and so I polished them with wire-wool, painted them black, revealed the lettering with fine abrasive on a sanding block and then varnished them. The finished product re-fitted to the freshly painted bulkhead was very encouraging. Newly inspired I then approached a local anti-corrosion specialist with all the suspension parts which I had decided to have blast-cleaned.

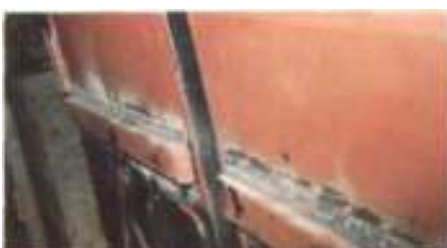
Underside after floor repair completed and prior to fitting of new jacking-point.

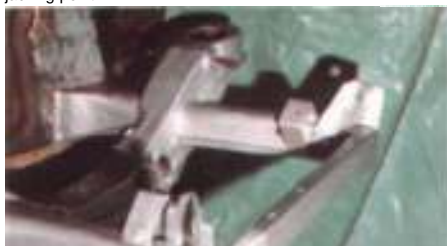
The result of a few weeks hard graft - the front chassis legs after stripping and repainting.

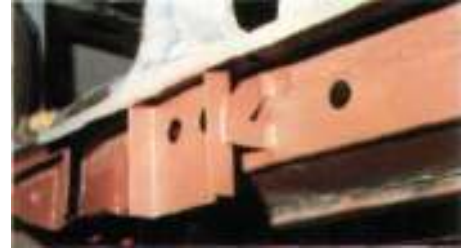
First step in installation of new jacking-point - 14 gauge inner strengthening parts welded in.

Repairs to the offside inner sills and floor went very smoothly. The only part which took some time was the jacking point, which on the Varitone is a steel tube fitted to the side-beam at its outer end and a floor stiffener on its inner end. The tube has to lift the entire side of the car and when the inner attachment had rusted away it had pivoted on the outer attachment point thus becoming worse than useless. My replacement was fabricated from a few hefty steel parts including a new length of tubing from a redundant office chair. The finished product resembles the original closely but is a lot stronger, having been semi-welded to the floor for its entire length and to a new floor stiffener at its inner end. In fact, it is so strong you could probably lift the car using it! Repairing straight sections and flat panels is relatively simple but it was pretty obvious that my ingenuity was going to be taxed making repair section for both rear wings and front wings.

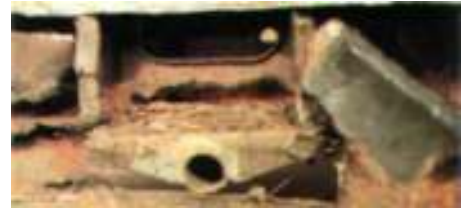
Offside jacking-point showing advanced decay revealed by removal of sill

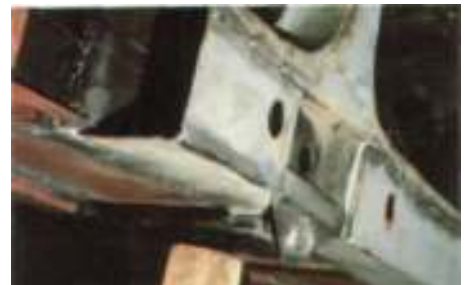
Showing relationship Between new jacking-point and already completed work on floor and sills.

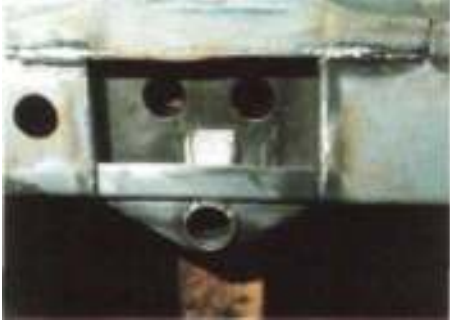
New offside jacking-point during installation

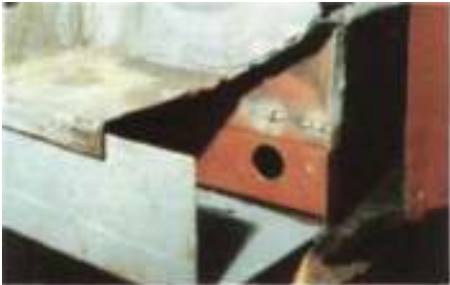
Front of offside side-beam showing how new parts have been fitted and prior to final finishing. The section with the circular ventilation hole is part of the new half-inner-sill panel and the L-section the new 14-gauge panel to replace the outer and lower parts of the beam.

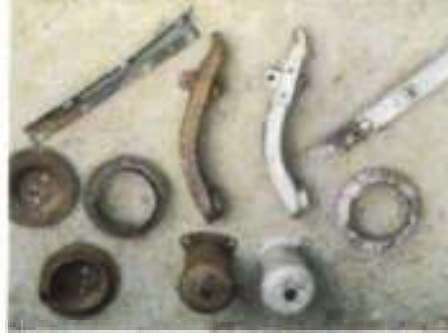
Some parts of front suspension before and after blast-cleaning.

Blast-cleaning cost me about £20 and was well worth it in time saved and quality achieved. A coat of black Hammerite following repairs to some parts which had partly rusted away and yet another job was completed. The front coil springs were blast-cleaned and shot-peened - a treatment recommended by my specialist to stress-relieve the metal. The springs were then spray-painted with the ubiquitous black Hammerite since it is no fun brush-painting coil-springs.
