Repair of the Sedan's A Pillar {A Post}

To save our Midgettes [MG ZA/ZB] we must cut out the cancer of rust as we find it. Some places are naturally more prone and critical than others and should not be ignored. The lower

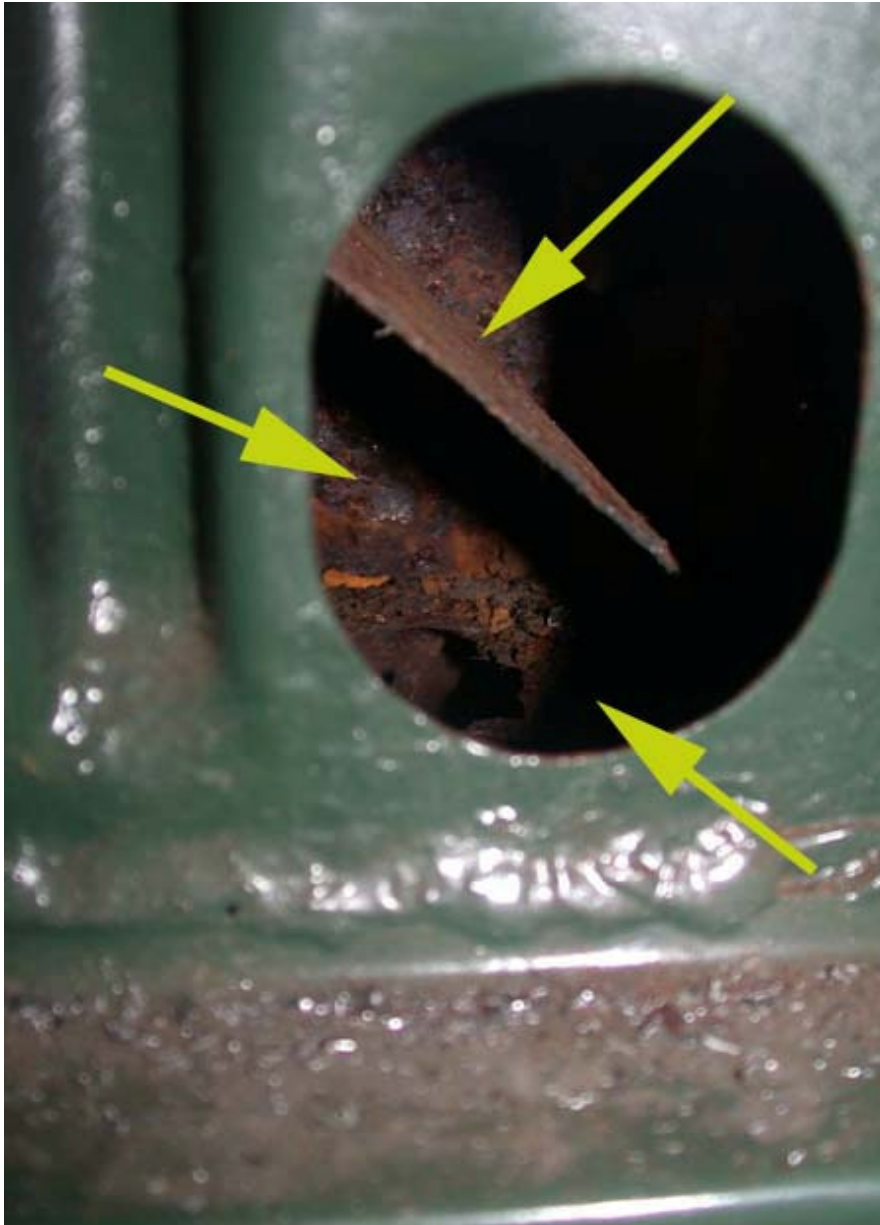
Externally the A pillar may or may not look to have problems but looking into this factory access reveals terminally advanced corrosion. Figure 1 Shows, in this situation, corrosion to: carrier extension, cavity walls, and top of inner sill.

Fig.1 From inside the car - Opening to bottom of A pillar

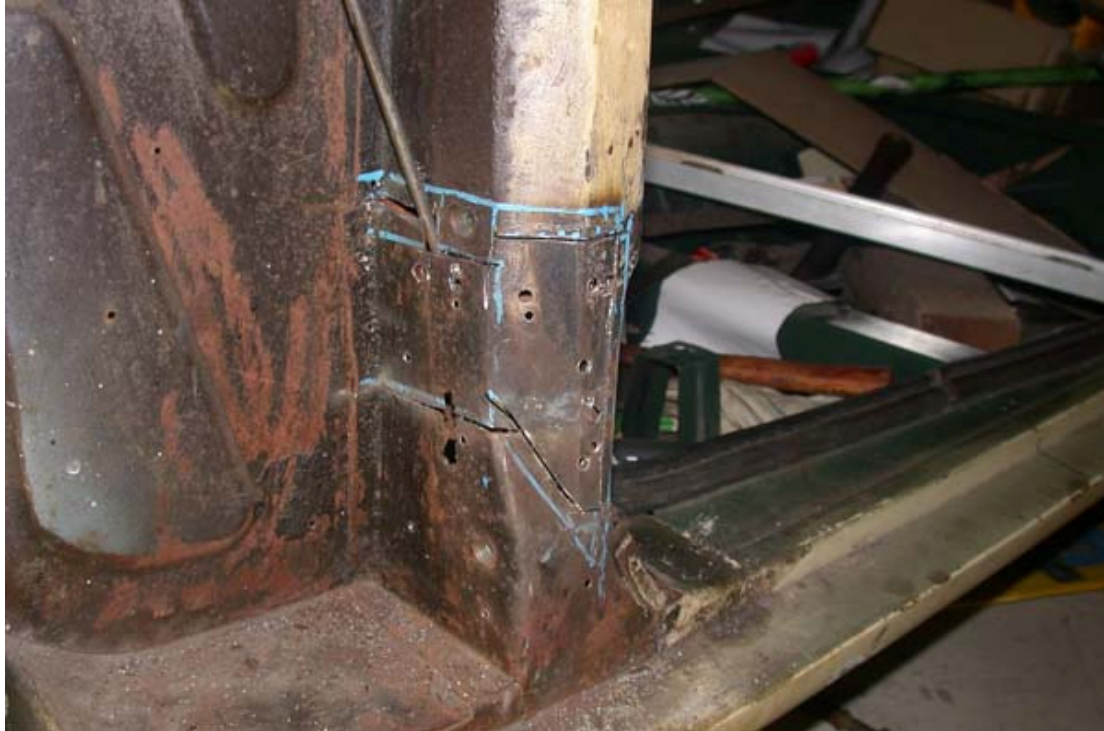
Figure 2 Lower A Pillar – Part outer skin being released from spot welds to access rusted carrier

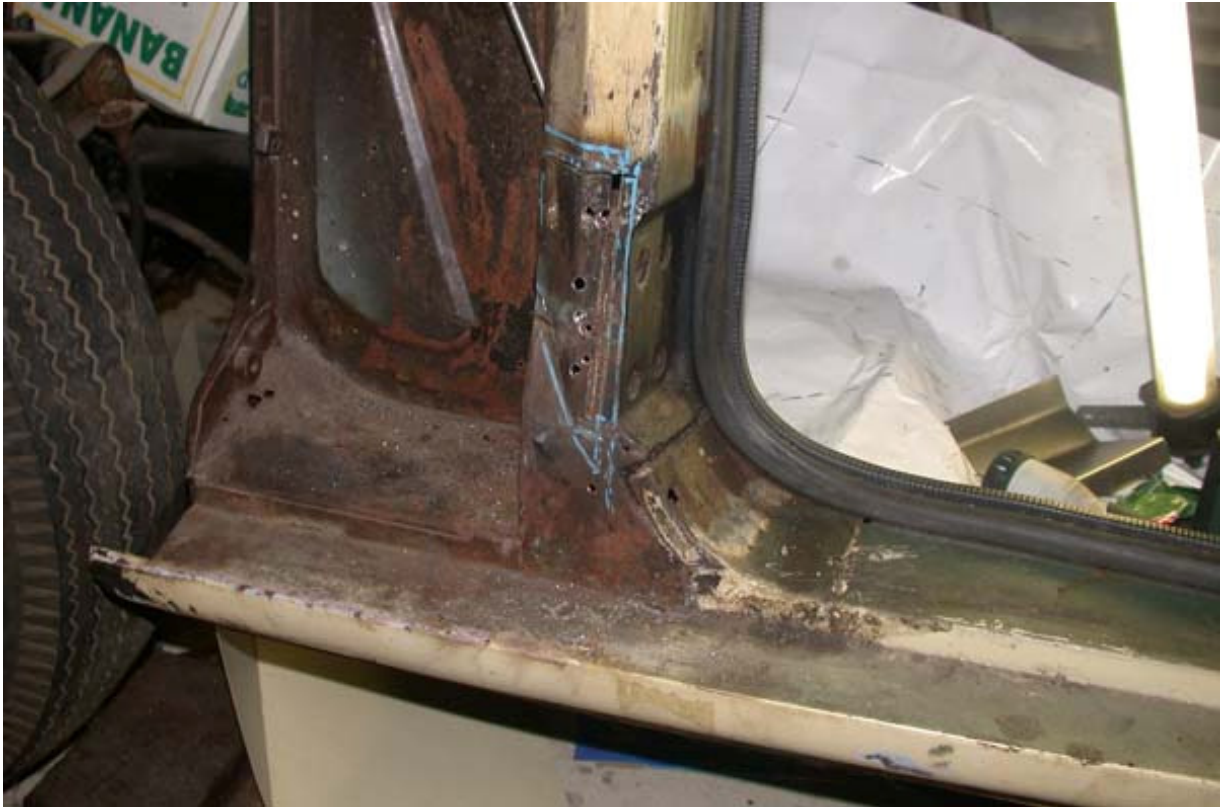
Fig 3 Alternative view of initial area to be sectioned out

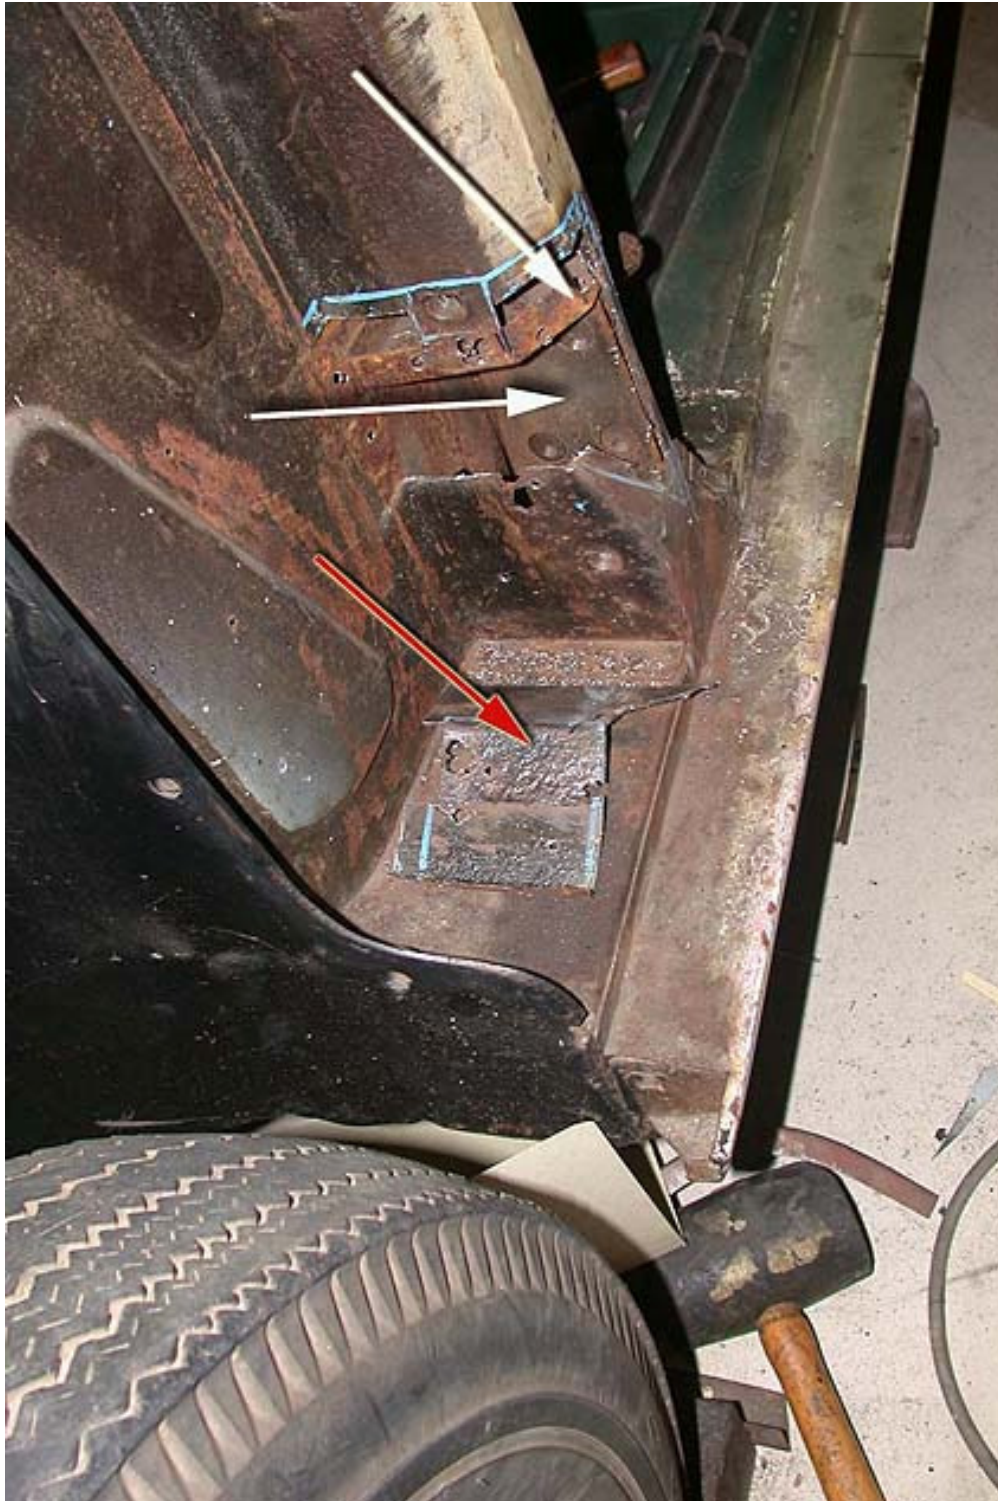
Fig 4 Access and horror

Figure 4 Shows the removed section is badly pitted. With access gained the final spot welds can now be released [drilled out] from the internal wall. Internal cavity can now be better assessed

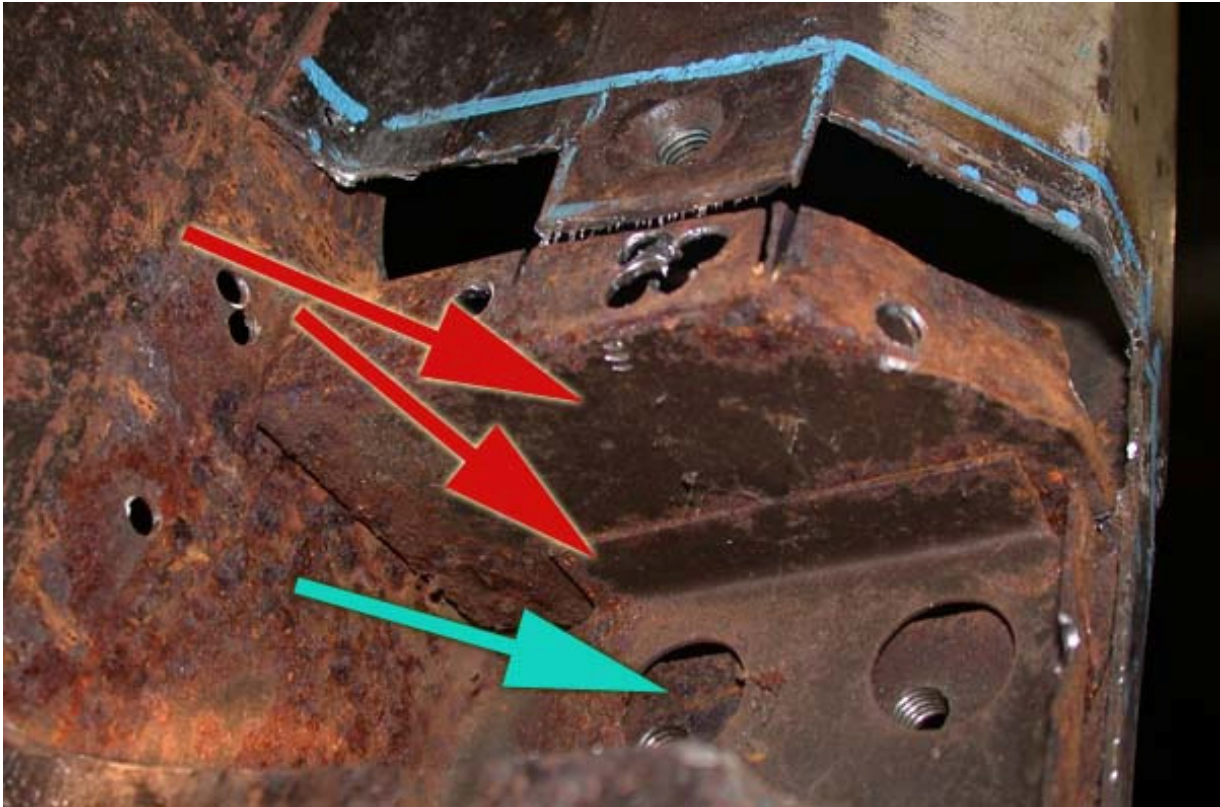
Fig 5 gives a better view of the carrier's reinforcing top.

Fig5 top portion showing construction and function of carrier; including its captive fixing plate.

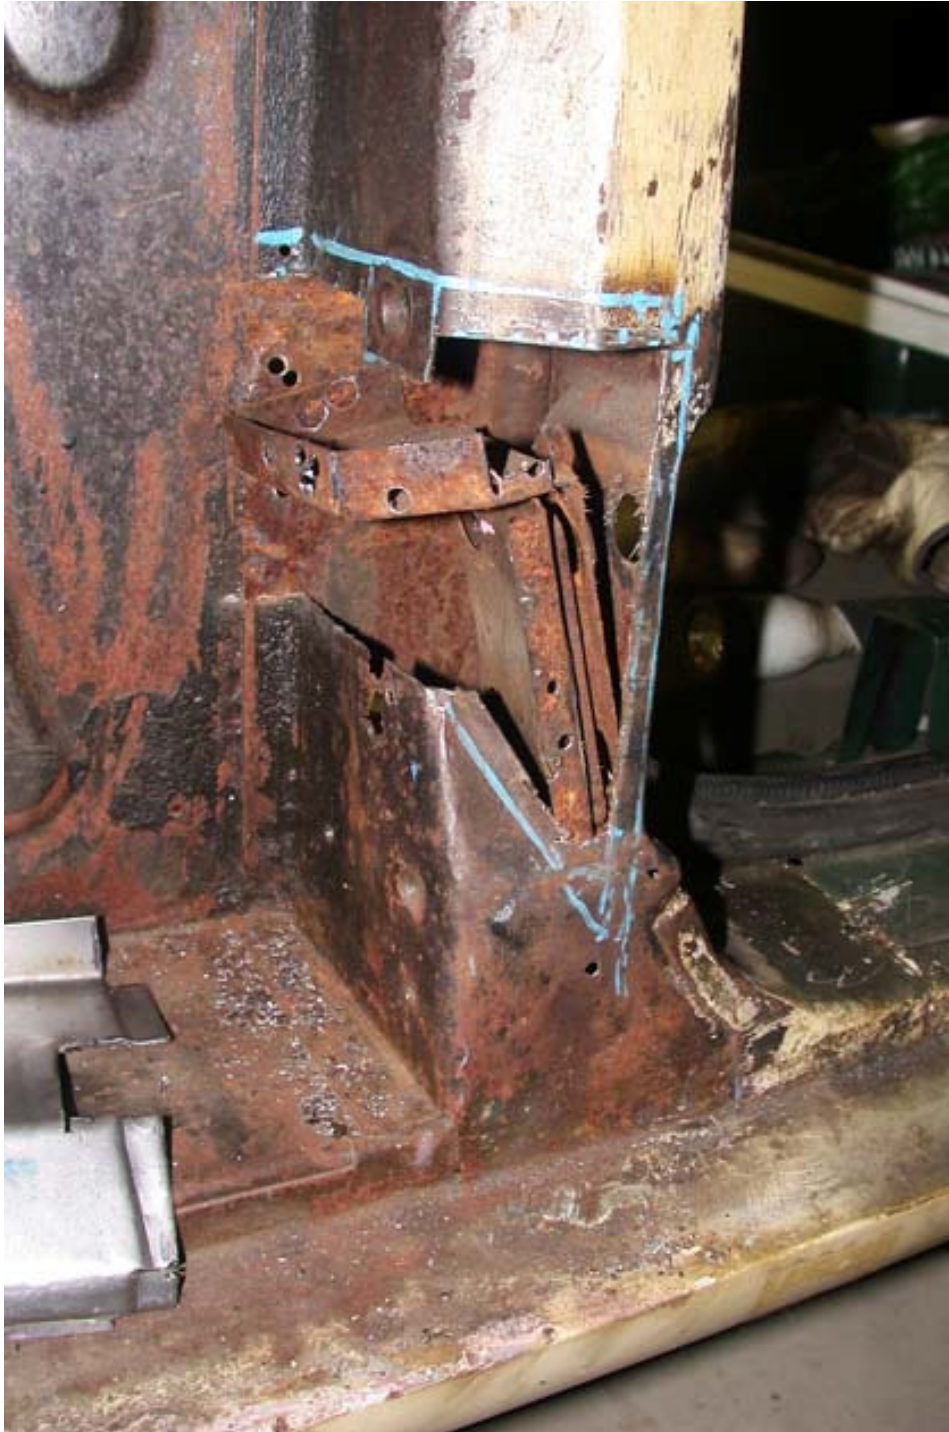
Fig6 Carrier has been partially released

Figure 6 gives a different view of internals with wall removed.

Three main items of interest are. **One;** carrier has had all of its upper spot welds drilled out. More spot welds need to be drilled out before the carrier's lower extension can be extracted.

Two; Revealed is one of four access holes in the hinge recess. Installation of a new carrier must align with those of the hinge recess.

Three; Partially shown is the fabricated multi sided replacement wall section.

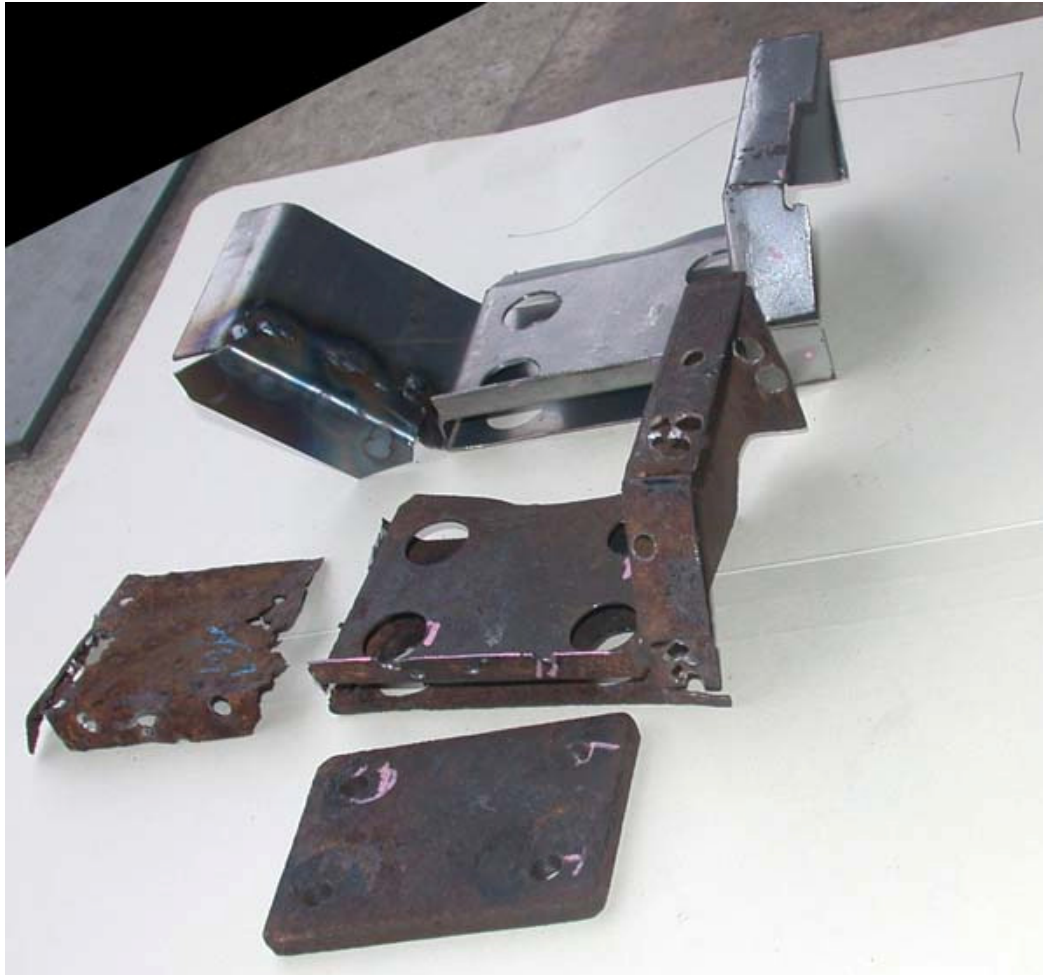
Fig 7 Fabricating the Carrier to take the original fixing plate

To fabricate a new carrier it is necessary to take cardboard patterns and measurements from the original. Plus it must be emphasized that the rusted carrier was removed very carefully to retain as much as possible of its original form with minimal distortion; even though the corrosion caused it to be reclaimed in two pieces.

Re-drilling the original pattern of four holes need to be executed accurately. Perhaps of interest is the original was used to reverse engineer the location and centre of the through holes. To this end a thin piece of paper was overlaid to gain a rubbing of [the four through holes] circumferences; and a drafting technique called the 'Chord Method', employed for finding the centre of each circumference [circle].

Finally the replacement carrier was fabricated in three pieces and welded into its unitary form. Original captive fixing plate [shown in Fig.7] was perfect and re-used in the new carrier.

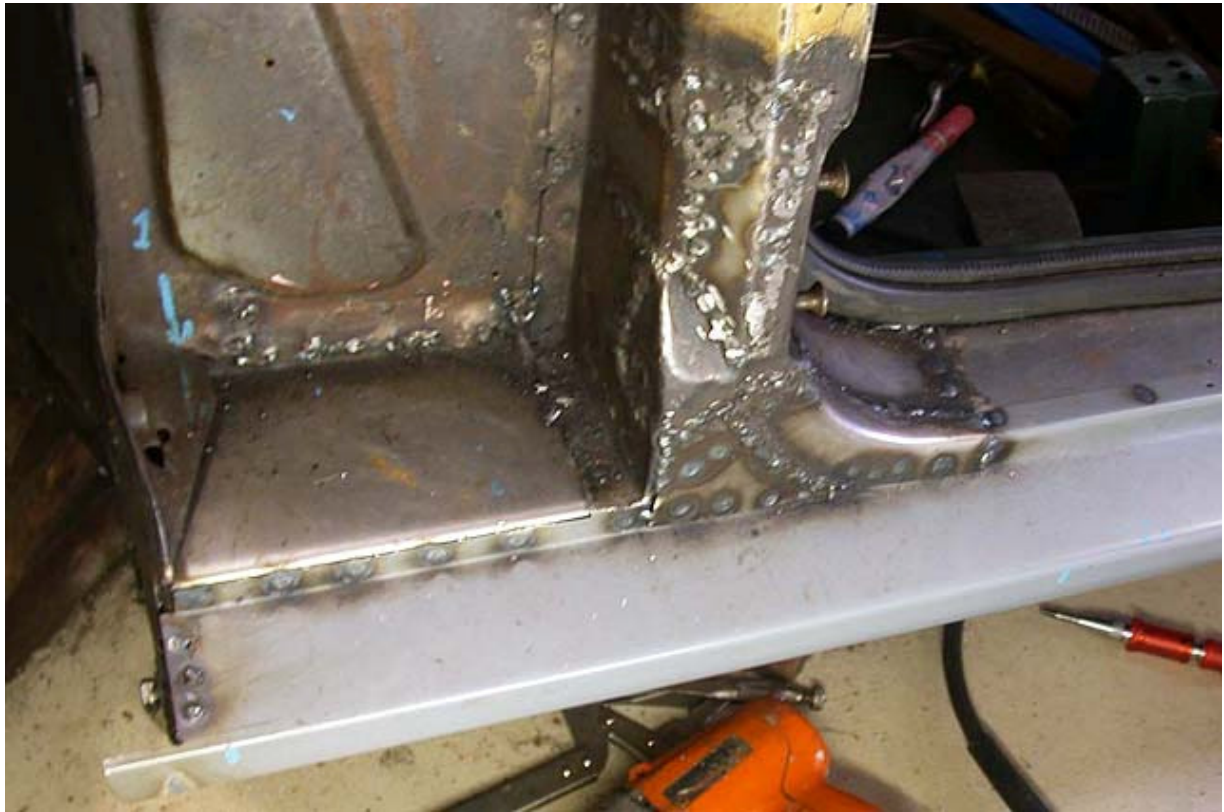
Figure 8 Finalising the A pillar fabrication

The outer repair of the A pillar had to be done using a sequence of fabricated replacement sheets. Of note is the progress of the A pillar repair had to halted part way through, to allow the outer and inner sills to be cut a way and replaced. Once new sills were in place the replacement sections and sills could all be welded together.

As a trial the door [front passenger side] was remounted and tested for full adjustment and movement.
