## CAR

My daughter Rachel married Alan Reynard on 6 April 2013 at the New Holmwood Hotel, Gurnard, Isle of Wight. My YB (0279) - aka UMG 576 - was her choice for bridal transport, and the Father of the Bride also took the role of chauffeur. A 1955 Humber Hawk, owned by a friend from the local Vectis Historic Car Club, provided transport for the three Bridesmaids and my wife, Mother of the Bride.

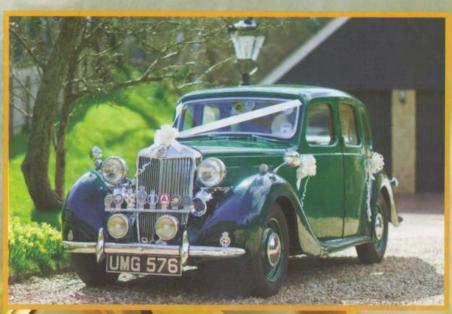
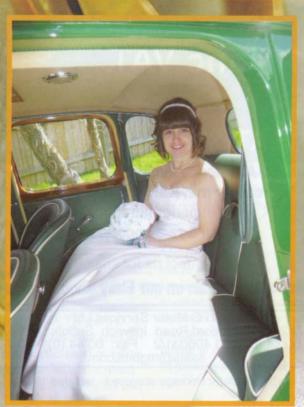
This showed that I could move the runners forward by an extra 3" without affecting the normal passenger seat position. 3" might not sound much, but it does make a noticeable difference to the room in the rear of the car. Rachel managed to get into and out of the car comfortably on the day, as can be seen from the photo.

I decided to move the passenger seat runners forward so that the seat could be moved further forward than intended. In order to avoid having to return them to their original position, I set the seat in its 'usual' position - a compromise between legroom at the front and rear. My wife, the usual front passenger is quite short, so I could be reasonably generous with the rear seat legroom. I then counted the notches from this position and the maximum rearward movement.
