MG ZA & ZB Mquette Indicators

Step forward the **DB10** relay

1955 – Z Type Magnette with Indicators & Brakes that Wink

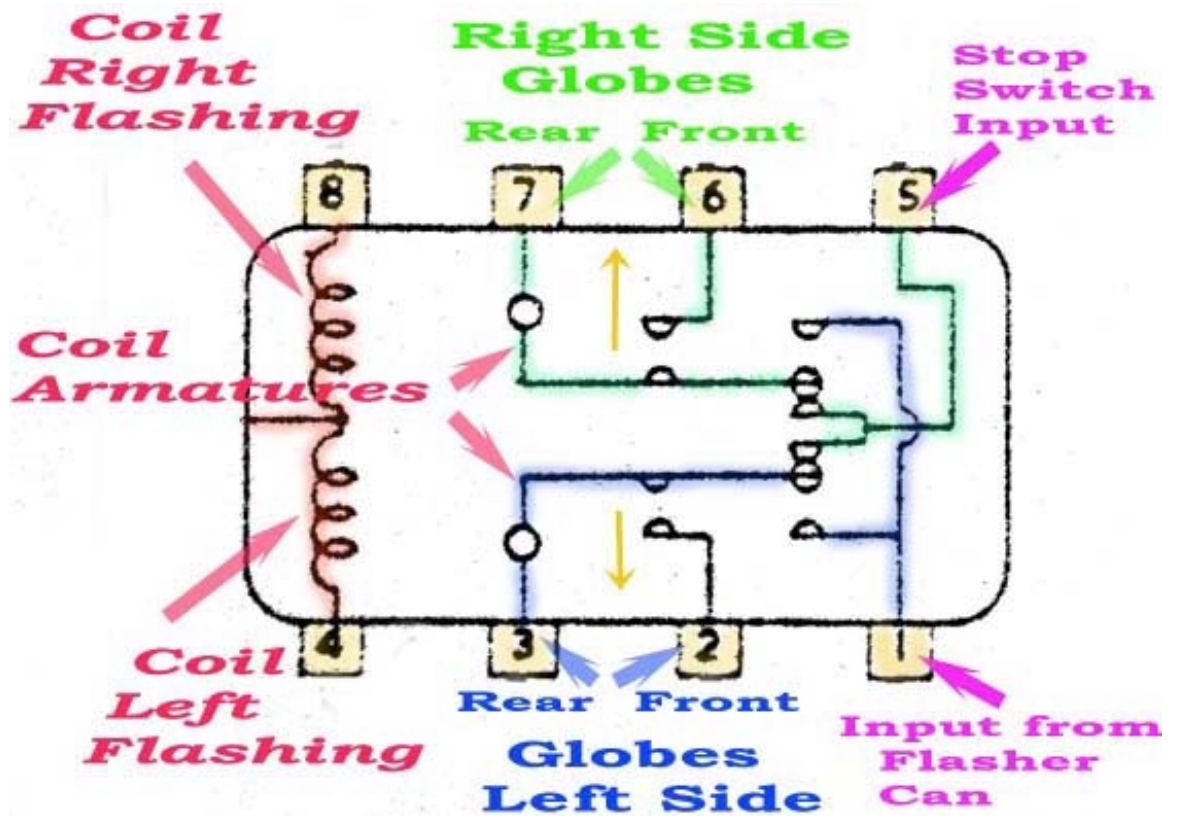
Fig. 3. DB10 Flasher Relay Circuit

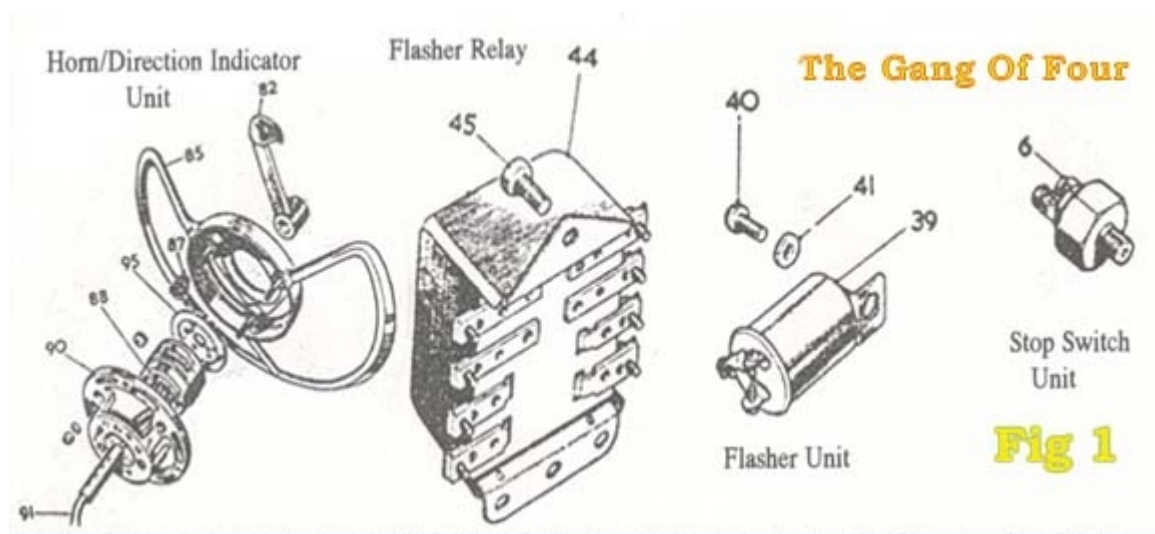
Fig 1 Gang of Four

Two new players have been added to make a gang of four. A need to fit indicators required the application of Flasher Relay and Flasher Unit to provide a solution.

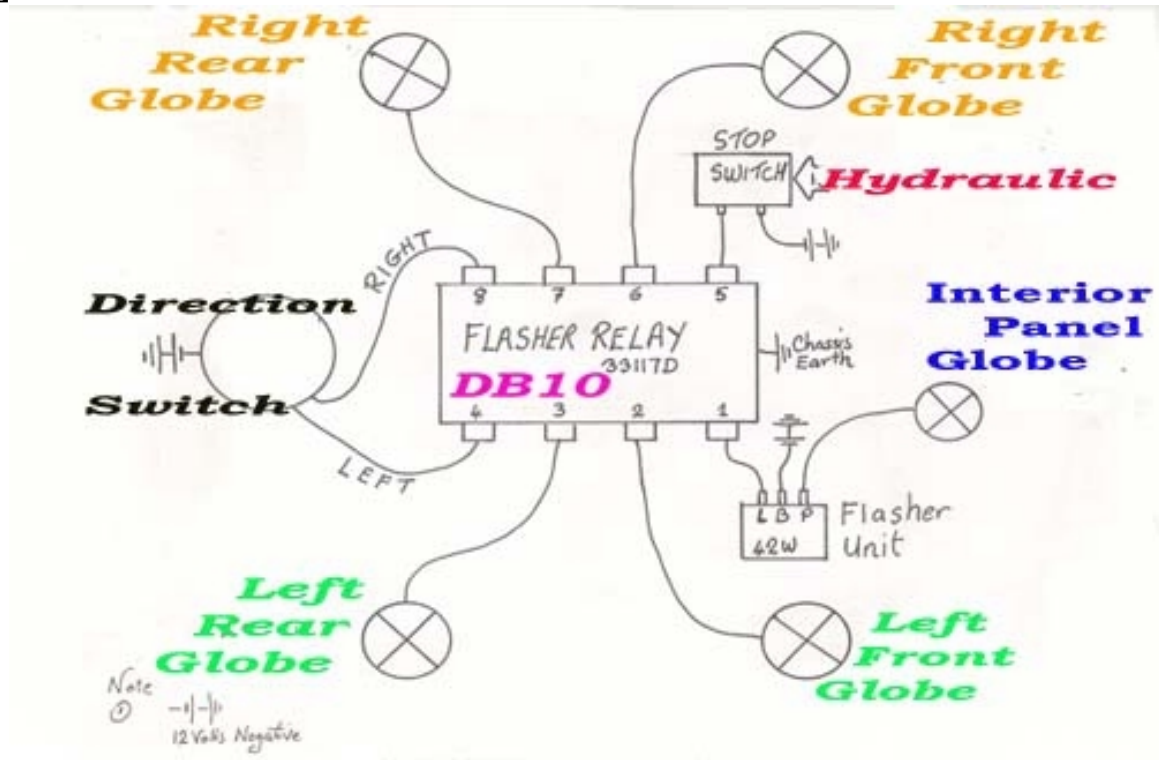
Figure (2) shows interconnectivity for the following basic functional needs:

One. Indicator lever on the steering wheel center controls whether left of right indicating lights flash.

Two. DB10 Relay primarily allows the braking lights and indicator lights to work separately or safely combined.

Fig.2 Interconnection for gang of four

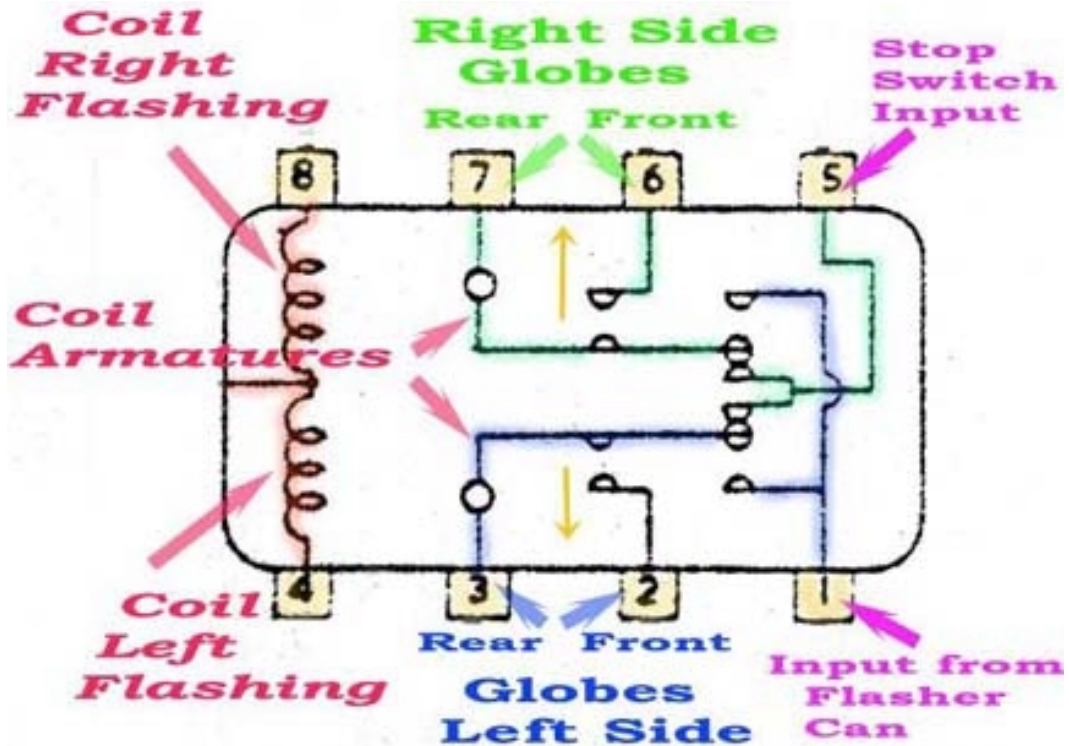
General. DB10 consists of two relay coils. One for activating right side indicator globes, other to activate left indicating globes. Fig 3 below shows DB10 in idle state.

Fig 3 DB10 in idle state

Idle State. As shown in Figures 2d, 3, 4a& 5a, both rear stop lights will glow when foot brake is operated. Stop light circuit activated via tags 5,7 & 3.

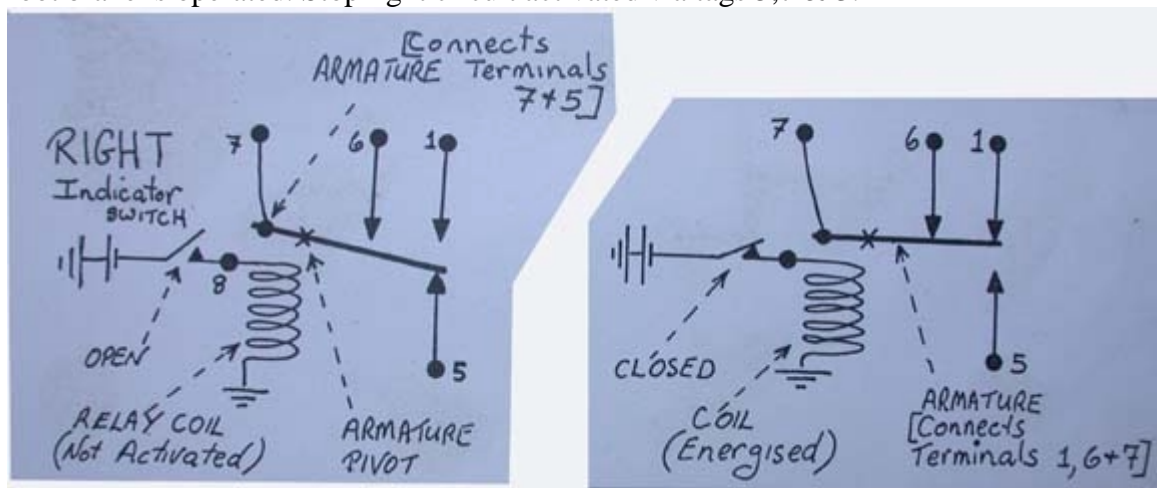
Fig4a Indicator Switch un-operated.

Fig 4b Right Indicator operated

Indicator Switch Operated to the right [Figures 5b, 2a, 4b & 6] activates relay at tag 8; joining tags 1,6 & 7 to flash right side globes. *Note. Right rear stop globe can only flash when brake is also pressed.*

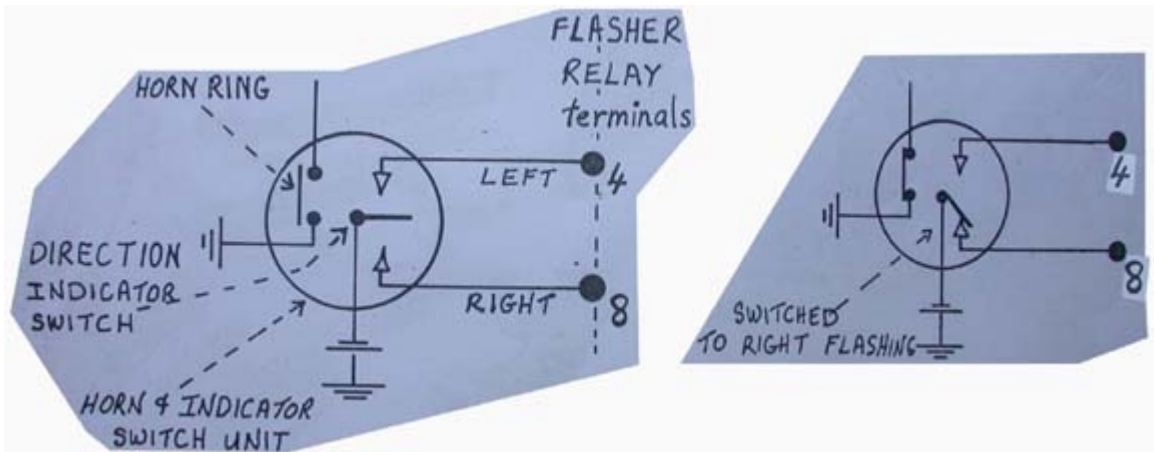
Fig. 5a Un-operated Indicator Switch

Fig. 5b Switched to Right

Indicator Switch {Left} Figures 2c, 3 & 5a show the other relay is energized via tag 4, causing tags 1,2 & 3 to be connected together and flash the left side globes. NB Stop switch now cannot light rear left stop globe, when brake peddle pushed.

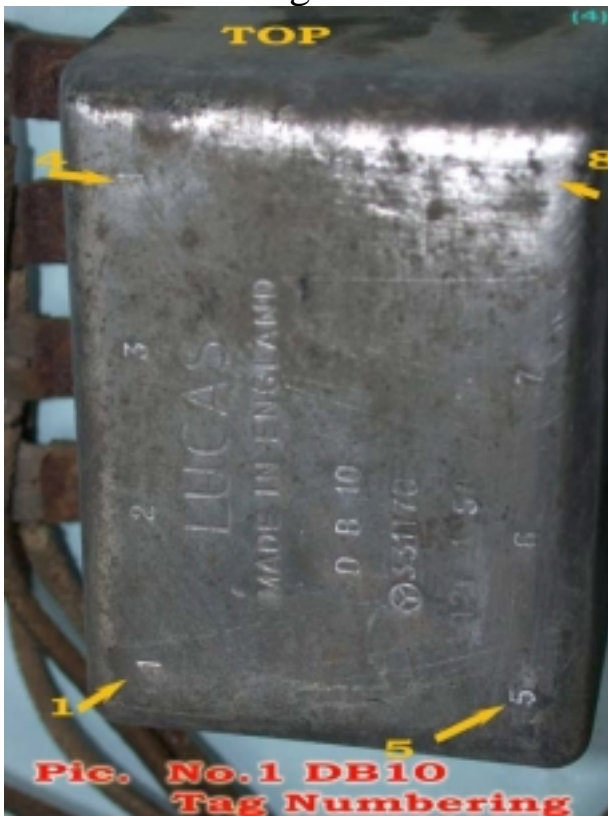
Picture 1. Wire Termination [Tag] Numbering

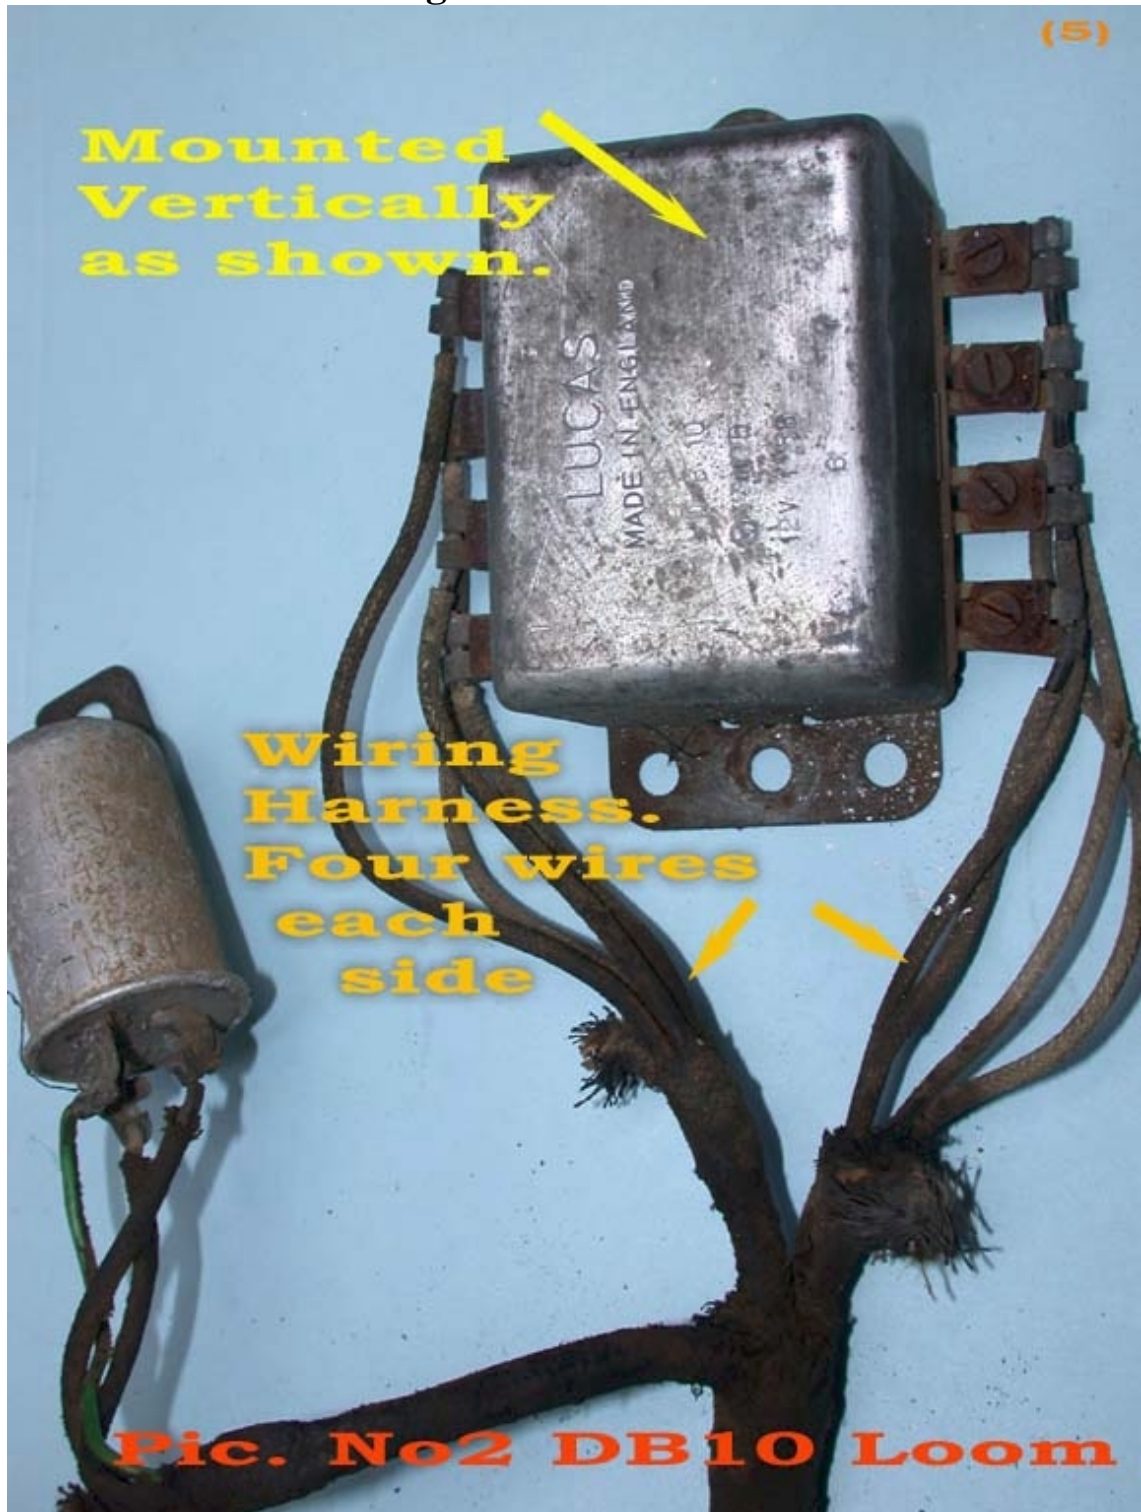
Picture No2 DB10 Loom

If a new loom is likely then wires can be included from tags 2 & 6, of the DB10 relay, to the rear for additional indicators [Bracket or body mounted].

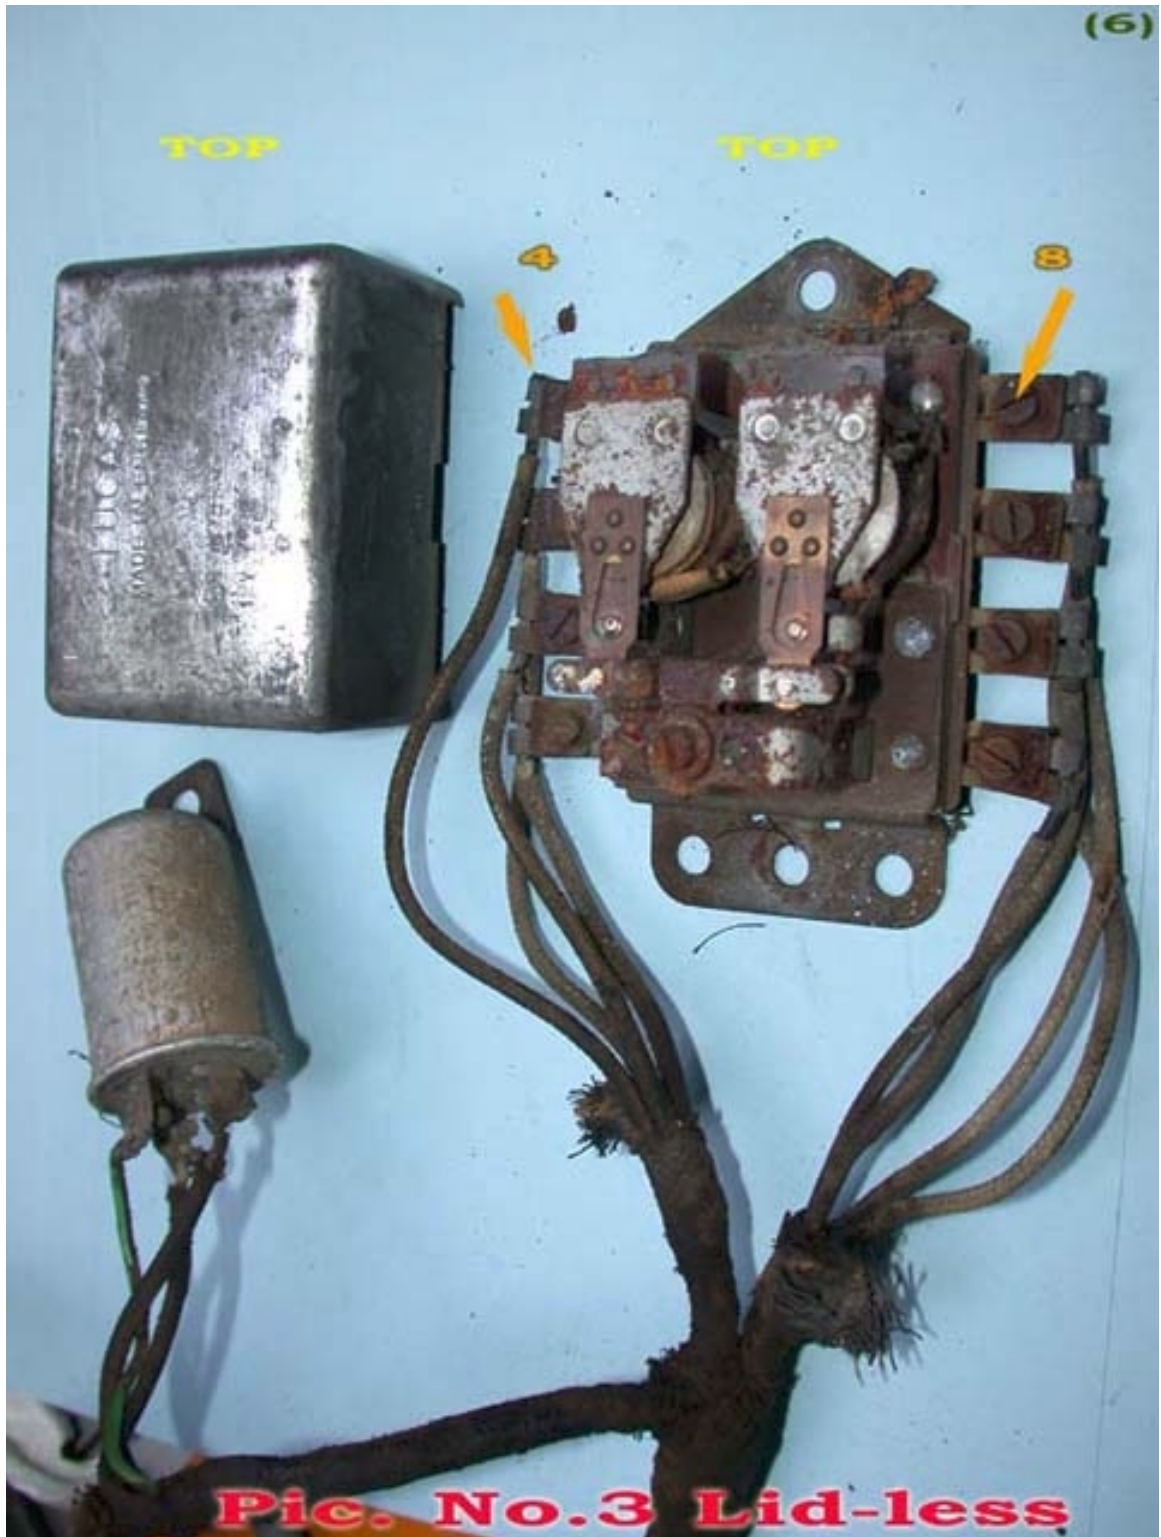
Picture No 3 Lid-less

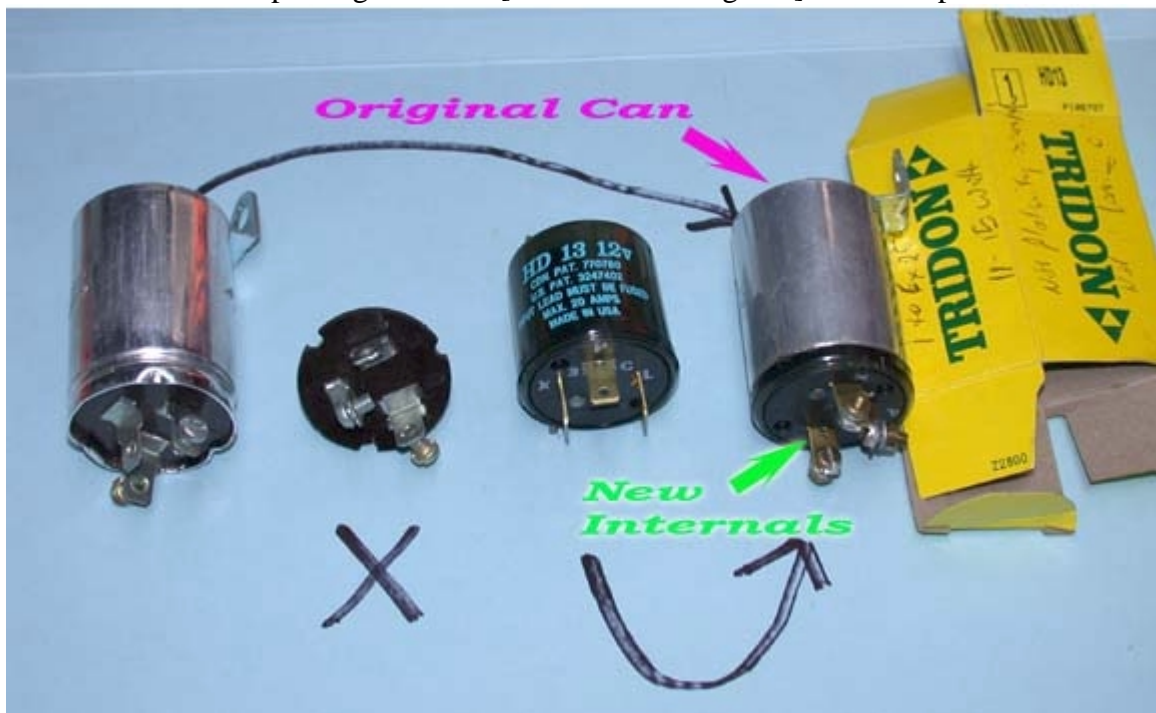
If the Indicator 'Can' unit goes faulty the options could be to replace with a genuine one or place a modern Indicator Unit {Pic. No. 4} inside a similar, looking, 'Can' to create a replacement.

Consider a modern 'flasher Can' such as HD13. Benefits of Tridon HD13 are: Drives six globes of 25 Watt each, better voltage tolerance, and not polarity sensitive.

Needs. Find Cans that fit together, trim any excess length and glue together with silicone. *NB. Drill a vent hole on bracket side [blind side] to release excess silicone and solder brass bolts to hold wire on tags.*

Picture No.4. Replacement Option.
