Cars Worth Keeping

MGYB

When it was finally back on the road, Philip Reckless had spent £1683.45 on restoring his 1952 MG saloon

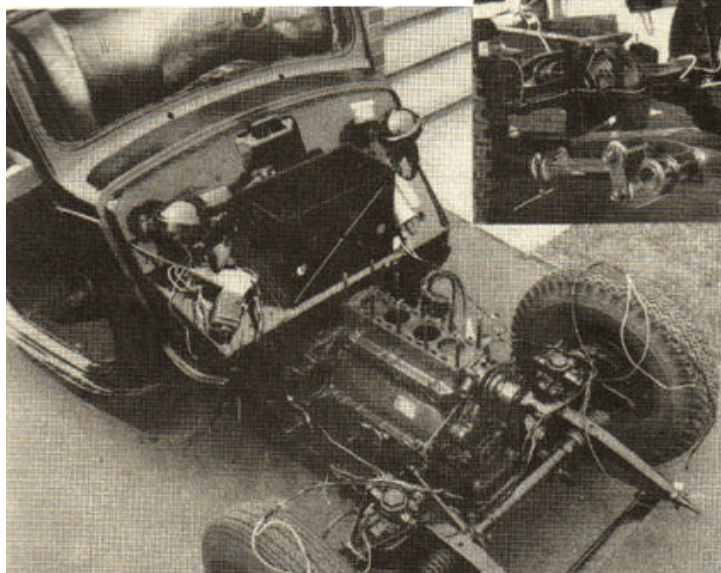
Front suspension renovations included replacing the front coil springs, one of which was found to be broken, although the car had been running on it before the rebuild. The engine was repainted MG red.
