MG Z-TYPE MAGNETTES

The sporty MG ZA and ZB Magnettes are poles apart from most 1950s saloons. Kim Henderson looks at their strengths and weaknesses.

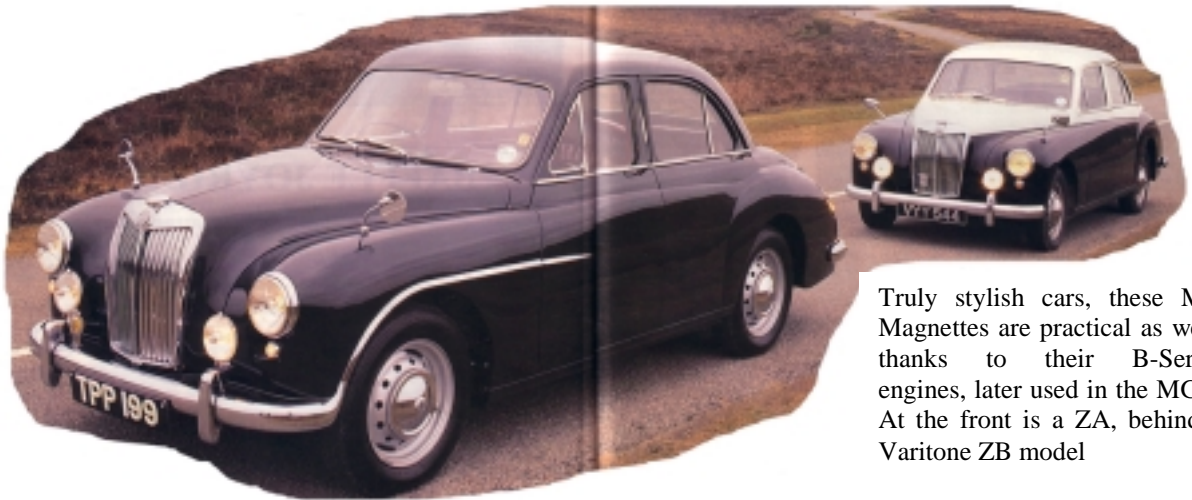
Truly stylish cars, these MG Magnettes are practical as well, thanks to their B-Series engines, later used in the MGB. At the front is a ZA, behind a Varitone ZB model

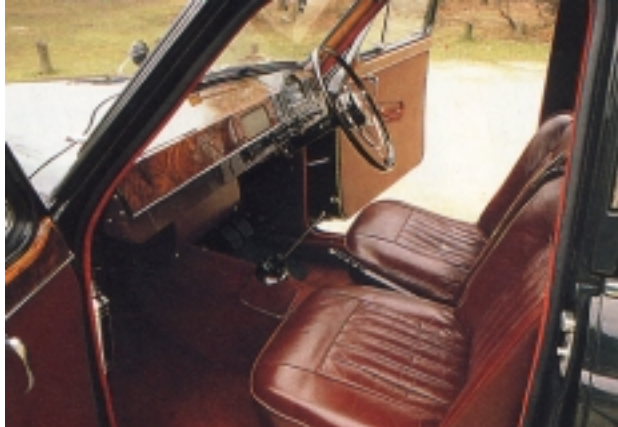
Early ZA models have a metal top dash, grained to look like wood. Leather restorer has been used on the seats.

The earliest ZAs had tin-top dashboards, but most cars you are likely to encounter have the later wood finish facias. All

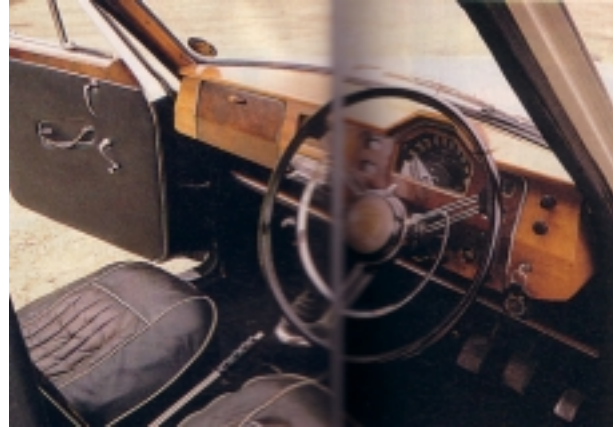
All Z-types have an attractive fascia with a good range of instruments – but no rev counter.

versions provide comprehensive information to the driver with instruments giving updates on battery charging rate, oil pressure and coolant temperature, the only significant omission being a rev-counter.

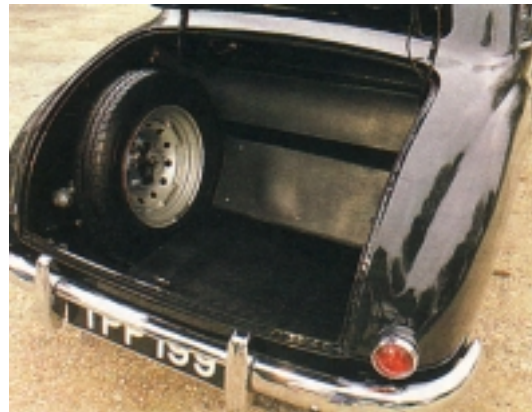
Vertically-mounted spare wheel shows depth of roomy boot, which has low loading height.

Although the tail of the car slopes restricting boot height at the rear end, the luggage space is wide and deep with the spare wheel housed vertically on the left hand side. Loading over the very low sill is from bumper height and easy.

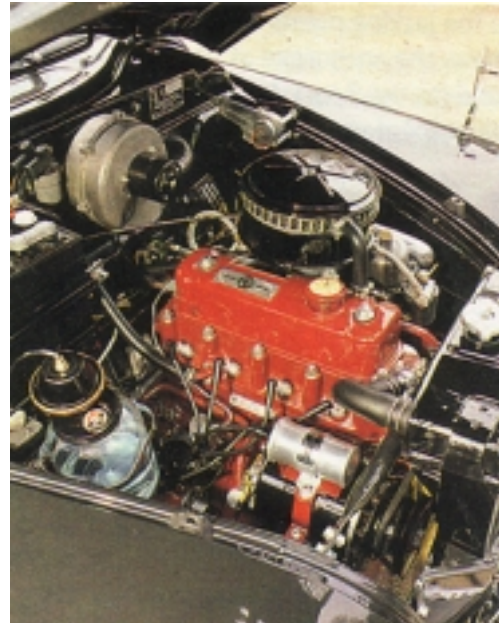
Immaculate engine compartment of Philip Jones's ZA model. Routine maintenance is easy.

With the possible exception of balancing the twin carburettors, which is time-consuming rather than difficult, and reaching the distributor, which is mounted well down within the engine bay, servicing a Z Series Magnette is very straightforward. So too is a decoke and a clutch change.

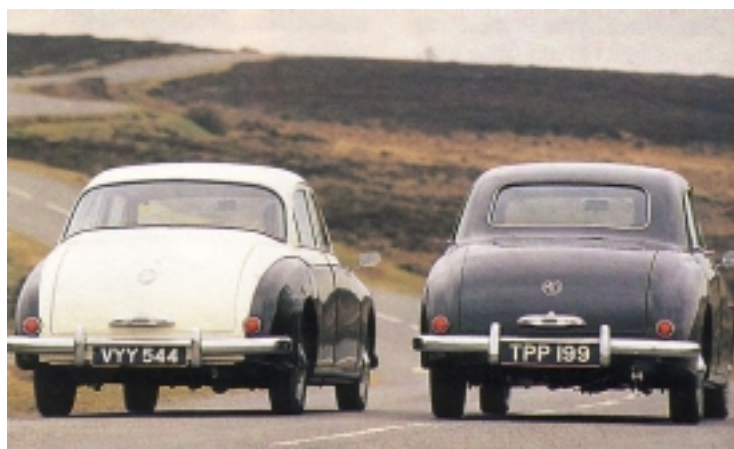
Apart from the Varitone's enlarged rear window, few styling changes were made during the 1953 – 58 production run.

October 1956: ZB arrives, with higher compression engine developing more power (twin u.sin. SU carburettors, revised manifolds, also double valve springs) and higher final drive ratio. Side body trims now straight. Steering wheel dished (ZA's was flatter). Flashing indicators. Varitone version normally supplied with two-tone paintwork. Varitone has wider, curved glass, wrap-around rear window. Manumatic semi-automatic transmission optional.
